# COMPLAINT FORM

Complaint #: 133505 Maximo #214450

Address: 1623 KEMPER AV

Project No. 02362-07

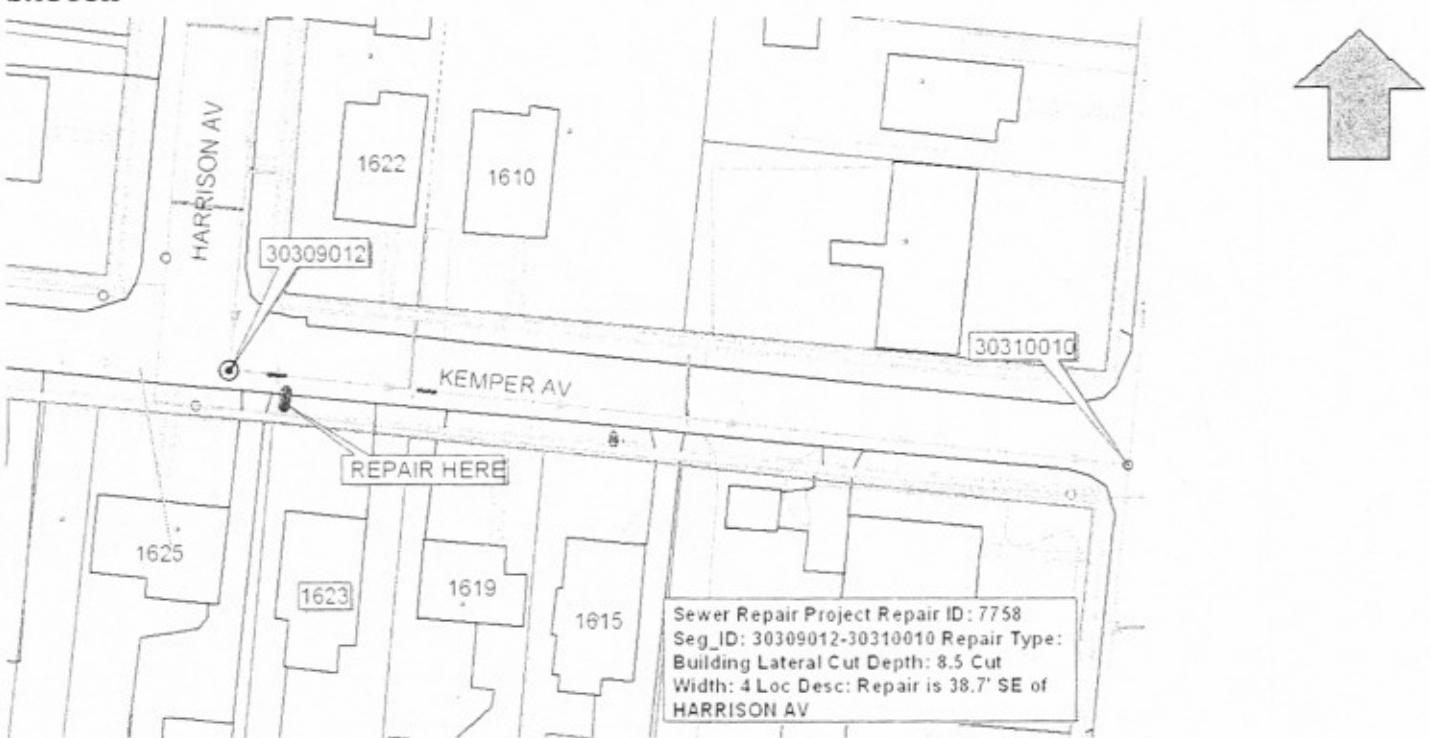
## Sketch

EMERG. TAP REPAIR, WIB DUE TO BUILDING LATERAL BEING DISCONNECTED FROM OLD COMMON TAP, PROBABLY FROM WORK BY DUKE IN 2005. NOTE: THERE IS A POWER POLE DIRECTLY OVER THE REPAIR LOCATION. ALREADY LOCATED AND MARKED, SEE TAP LOCATION SHEET.-- crew laid 7.5' of 6" pipe.

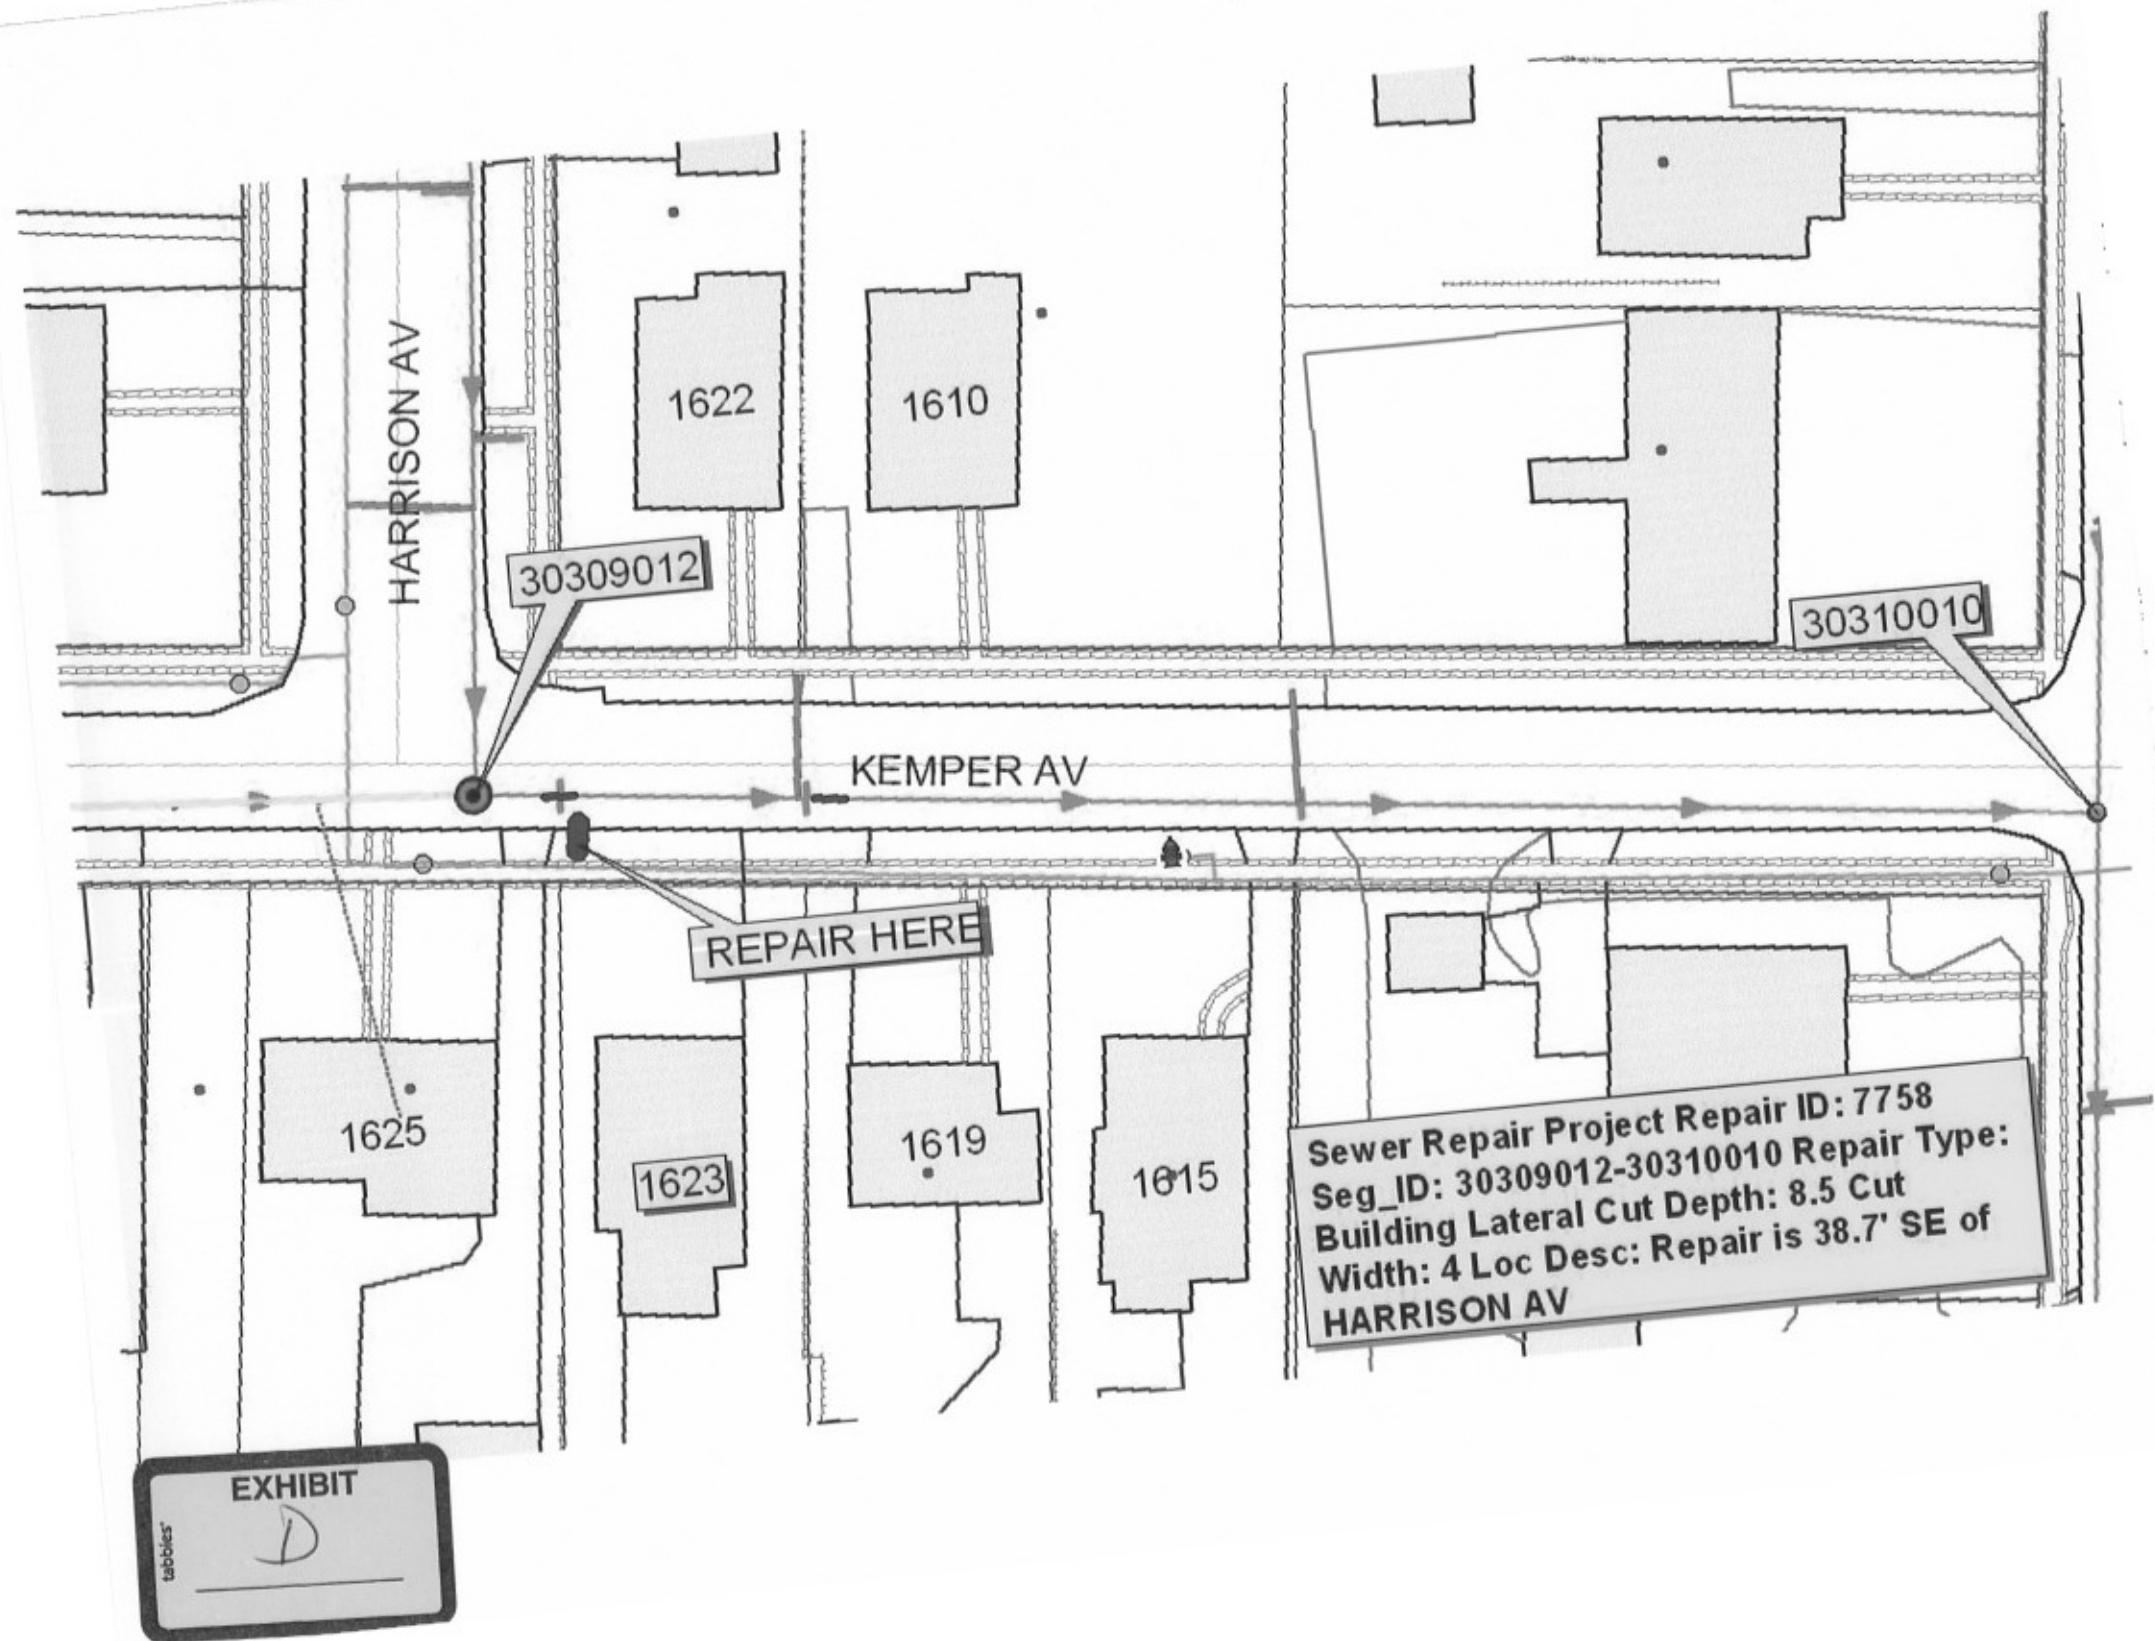
Comments: PICK UP TAPE FOR REVIEW. DRAINS VERY SLOWLY. C/ THINKS TELEPHONE POLE HAS COLLAPSE HIS LATERAL. MSD REPAIRED ON 3-2-07 (204919) & RODDED ON 7-6-07 (212846). I ARRIVED & PICKED UP TAPE. REFER TO R. SCHNEIDER TO REVIEW TAPE. G. ROGERS 12-6-07 REF TO R. SCHNEIDER. K. RUSSELL 12/6/07 WOG DUBBED VIDEO INTO PLUMBER'S VIDEO ON L DRIVE. COPIED M. MUELLER TO LAUNCH TO R/W & LOCATE & WITNESS DEFECT. REFER TO DISPATCH TO RETURN TAPE. RRS 12-10-07 12/10/07 #445 ARRIVED 18:23 FINISHED 18:33 I RETURNED TAPE. C/ WAS NOT HOME. I LEFT TAPE ON SHELF ON BACK PORCH, OUT OF THE RAIN. I A/C BY VOICEMAIL. G. ROGERS 12/10/07
